Navajo Abandoned Uranium Mine

Site Screen Report

Mine Name: Lemuel Littleman No. 7
Mine ID: 374

August 2011

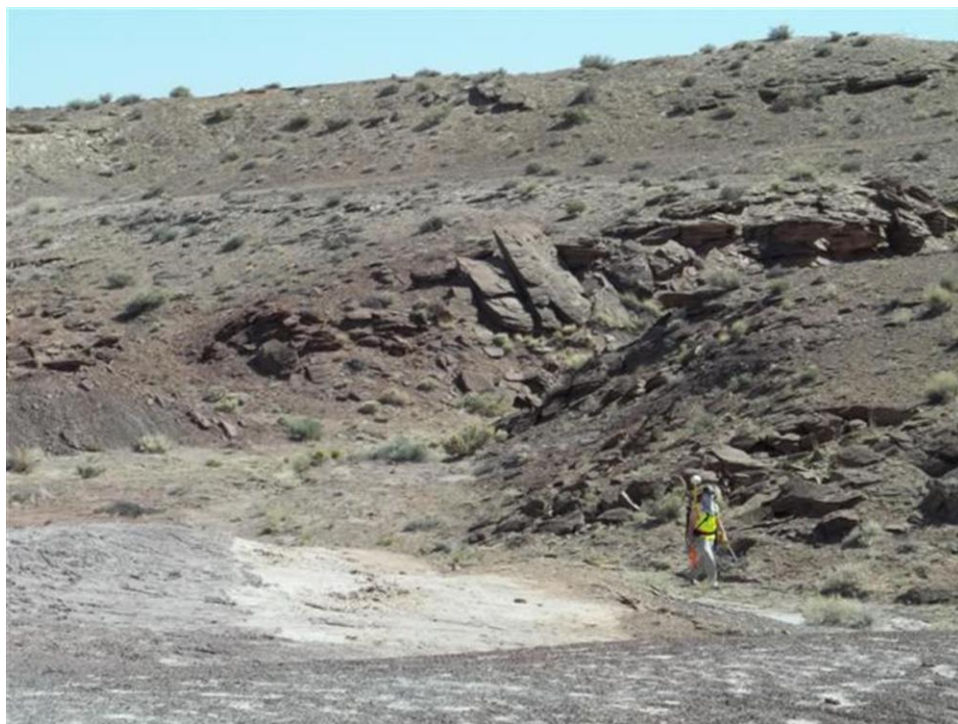
Photo 2: Mine Site #374; Southeast drainage

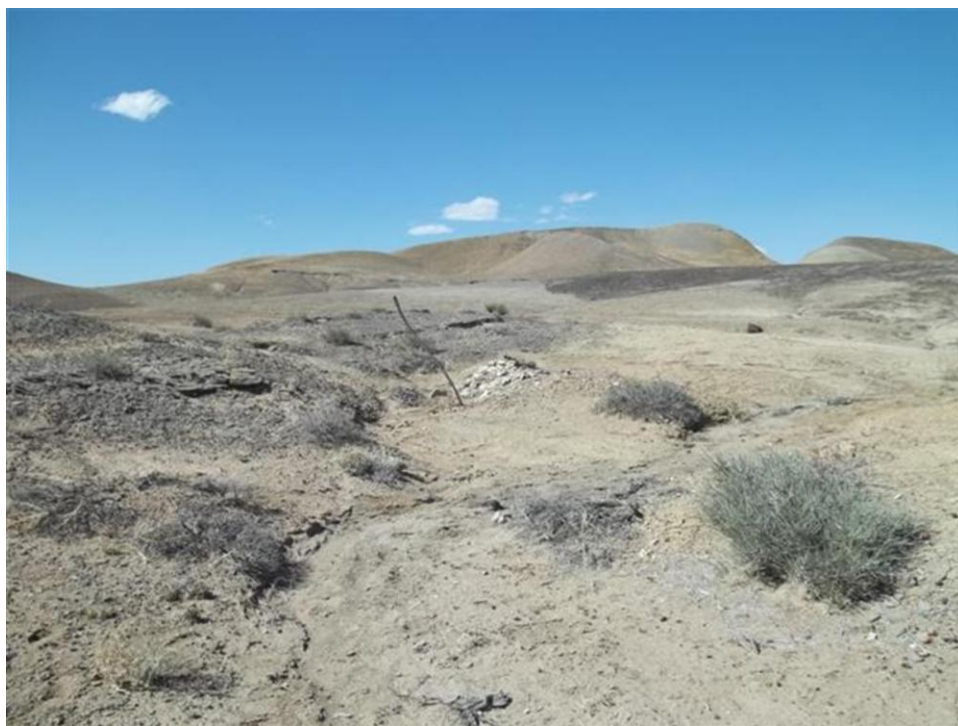
Mining debris (drills, cans) in northeast drainage

Photo 3: Mine Site #374; North drainage with debris and elevated readings
